Flood Risk Categorisation, Ex-Tropical Cyclone Gabrielle Impacted Areas

Hawkes Bay Regional Council

• June 2023

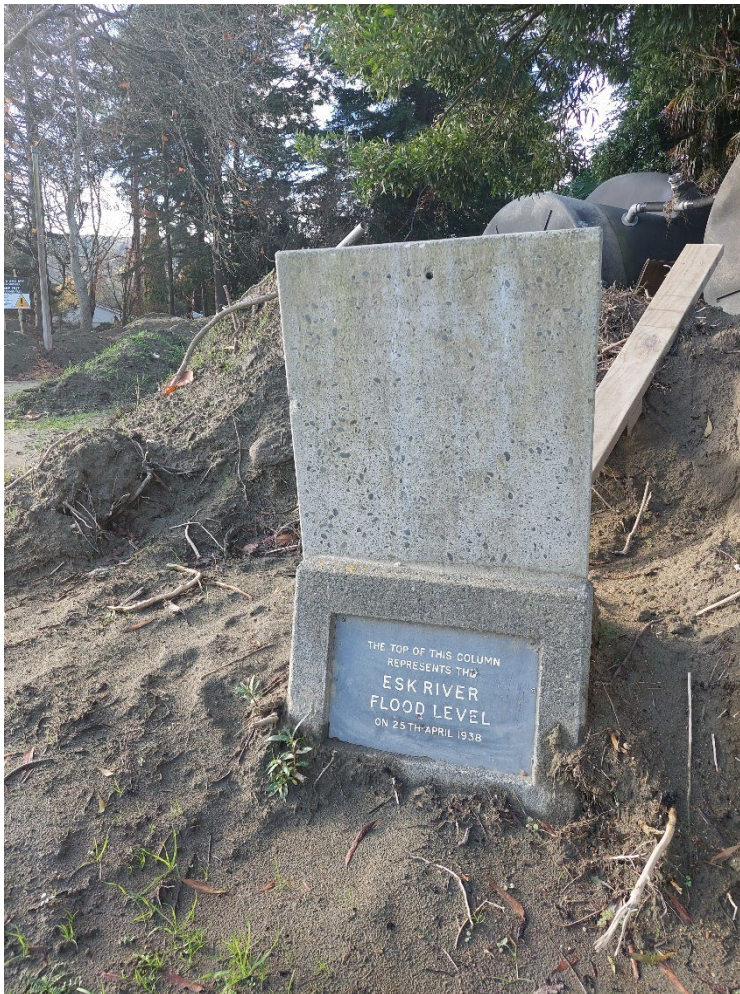
Figure 1 – 1938 Flood Marker beside Shaw Road, Lower Esk Valley

Esk Valley impacts were particularly extreme, depositing metres of silt in places and entraining significant volumes of flood debris (trees that slipped into the river and its tributaries and/ or were ripped from river banks). The devastation that wrought to the valley had been well-documented elsewhere and is not repeated in this report. Shaw Road was arguably at the epicentre of those Esk Valley impacts – a visit to Shaw Road noted the marker placed beside the road recording the 1938 flood height, with the flood height of ETC Gabrielle significantly higher.

Two flood occurred in 1938 – one in February and one in April. The February event focussed more on Tairāwhiti and resulted in the deaths of 21 people at Kopuawhara near Mahia Peninsula (the Kopuawhara disaster) – described as a flash flood (a 5m high “wall of water”). The April event impacted Hawkes Bay, causing catastrophic damage to the Esk Valley in particular.

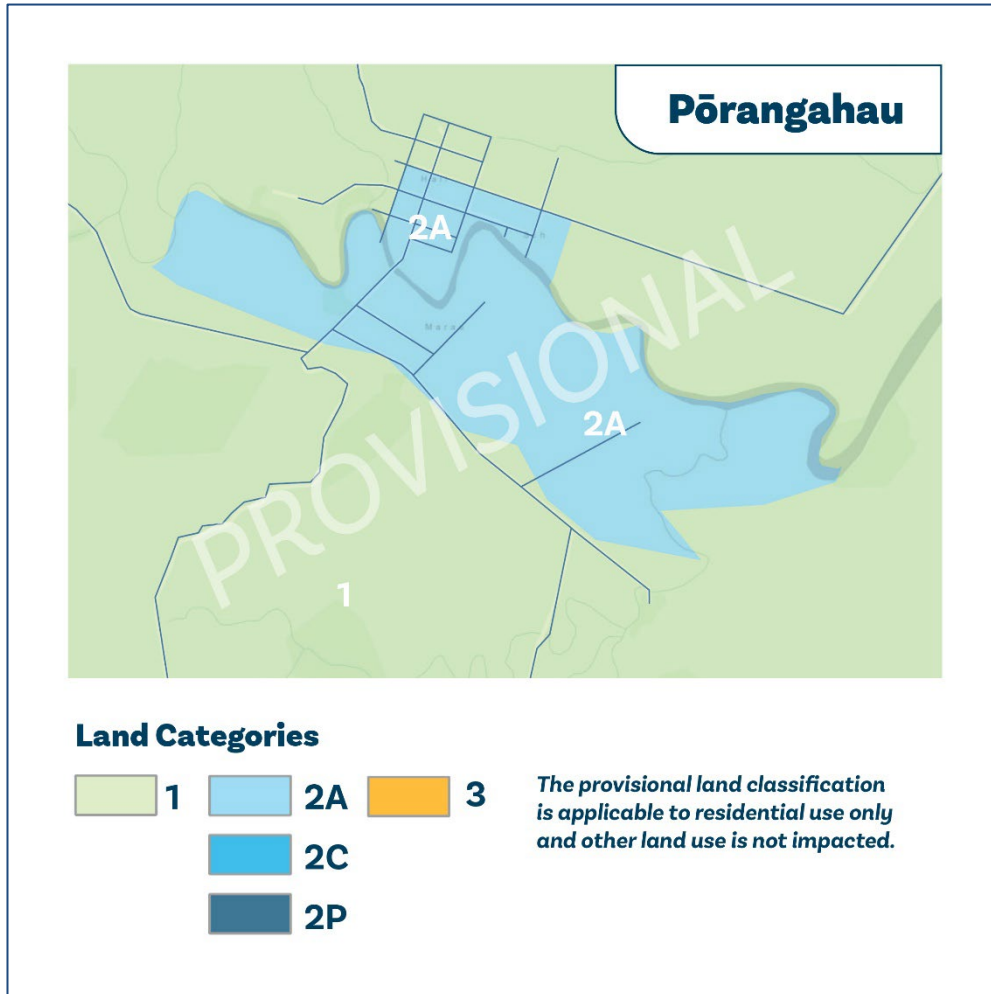
The town of Porangahau in southern Hawkes Bay was significantly impacted during ETC Gabrielle. The town is located on the north bank of the river a short distance from the coast with the flood peak in the Porangahau River coinciding with high tide, exacerbating flooding. The town has no flood defences and around 35 houses, a marae and urupa (both on the south side of the river) were flooded.

It has been assigned a 2A categorisation – further investigation is required to determine whether a protection scheme for the town is viable or if property-level/specific interventions are the best mitigation approach.
